Wolf Ranch Outage Summary

City of Georgetown

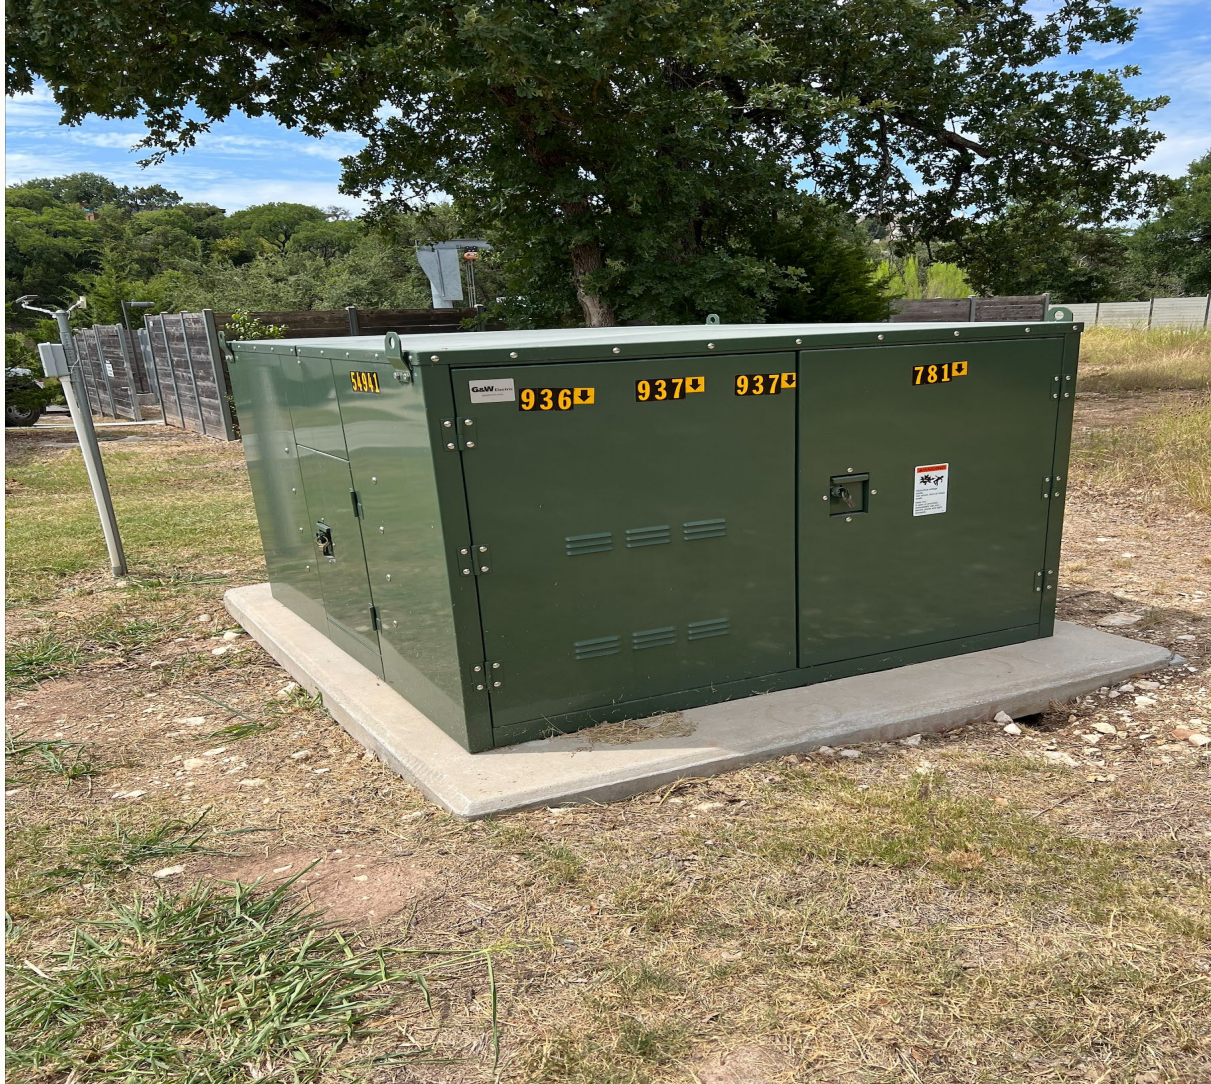
5/16/2023 Outage start time was 2:35pm, duration was approximately 2 hours affecting 2115 customers in the Wolf Ranch area. The cause of the outage was lightning which damaged a key piece of electric equipment called a switchgear.

This was the third switchgear in a 2-month period that had experienced catastrophic failure due to lightning.

- Sent the damaged switchgear back to the vendor for a detailed investigation to verify the cause of the failure.
- An electric crew inspected the switchgear in the immediate area of Wolf Ranch to proactively identify any potential issues.
- Electric Engineering reviewed the circuits to verify coordination/system protection was correct in the area.
